Excerpted from Volume 8, Issue 8 · June 2007

Multiple Complications in an Occupied Home

*Timothy D. Toburen
Consultant
Indoor Environmental
Technologies
Clearwater, Fla.*

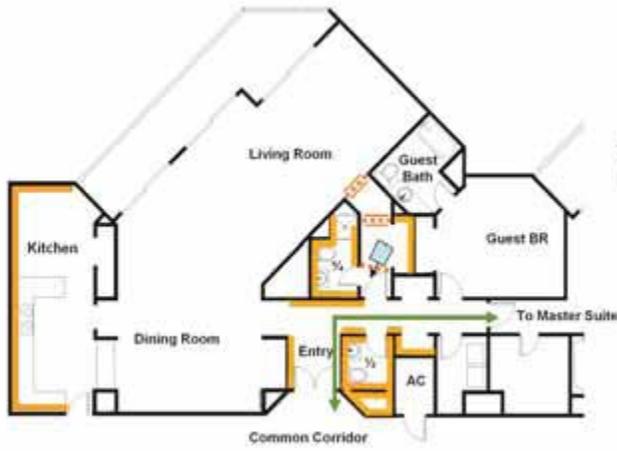
**Floor Plan 1:
Areas of Mold Growth
Phase 1 Remediation**

Mold growth was found in numerous locations in this unit (*See Floor Plan 1, page 5*). The apparent source of moisture in most of these areas appears to be roof leaks over the years, primarily around exhaust stacks, plumbing vent stacks, building expansion joints and the points where air-conditioning refrigerant lines penetrate the roof. Since the integrity of the roof was the responsibility of the condominium association, they agreed to pay for necessary remediation.

space had been minimal. This allowed greater flexibility in developing remediation plans. Mold growth was found in the areas shown on Floor Plan 1.

Moisture intrusion in this area was primarily through a building expansion joint on the west wall behind the kitchen cabinets. It had caused significant mold growth in wall cavities and on the back of wall and base cabinets, as well as water damage to these and other materials (*See Floor Plans 1 and 3, page 5*).

Containment was established over the central hallway closet to remove a relatively small amount of mold growth. While this work was being done, the owners accessed the unit and the master suite through either the main entry door or the kitchen door (*Again, see Floor Plan 1*).

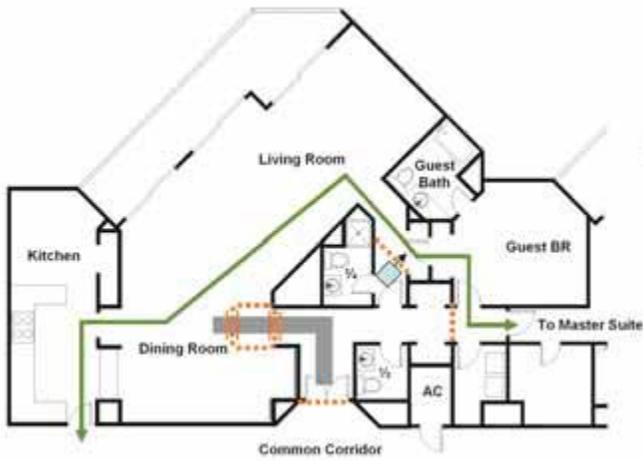
**Floor Plan 2:
Phase 2 Remediation**

- It was determined that the shower in the three-quarters bathroom also had to be removed.
- Extensive mold growth was found on the back side of common corridor wall drywall in the half bathroom near the entry. Fire code regulations prohibited removing both sides of this wall at the same time. The wall cavities and exposed drywall surfaces were thoroughly cleaned, and the drywall was coated with an antimicrobial encapsulant product. After completion of reconstruction in the unit, containment was erected over this wall from the corridor side and the contaminated materials were properly remediated.

This phase included the majority of the work in the unit. It involved the nearly complete removal of drywall and flooring materials in the main entry, hall leading to the master suite, half bathroom near the entry, and the three-quarters bathroom off the living room (*See Floor Plan 2, page 5*).

The only access to the master suite is through a hallway, which was included in this phase of the work. To allow continued access to the master suite, we directed the contractor to cut through the back wall of the closet off the center hallway, which had been remediated in Phase 1, into the closet of the guest bedroom, then install a pre-hung door in the opening. Throughout Phase 2 remediation, the owners accessed their master suite through this temporary door, with access to the unit through the kitchen door.

with maintaining negative pressure in the work area. The contractor and we designed and installed an airtight return duct extension that extended across the work zone and through a containment barrier, allowing return air to be drawn from a non-contaminated part of the unit.
