### OVERVIEW

IET worked with a multi-disciplinary investigative team to determine the procedures needed to bring this 10 year old, 1,000,000 square feet dorm complex with deferred maintenance issues back into good condition.

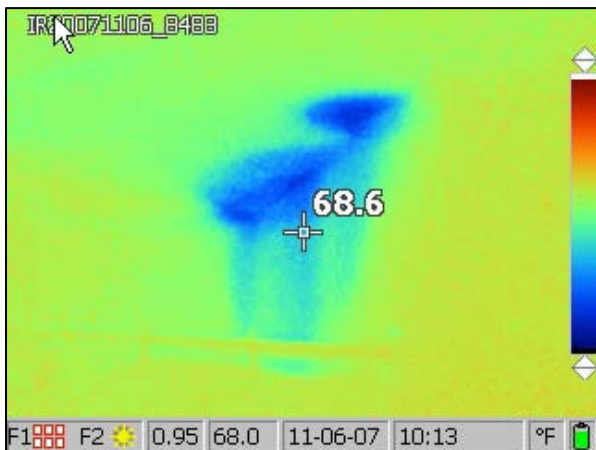
Using thermal imaging and moisture mapping, IET was able to document significant moisture intrusion issues caused by building envelope failure and by repeated flooding of dorm rooms due to inadequate design and maintenance of dorm unit bathroom facilities.

Thermal image of wet materials above bathtub in dorm unit bathroom

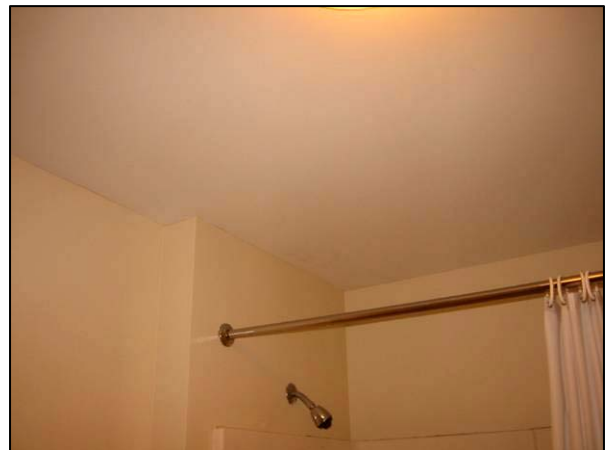
Visible light image of location at left
